MARIPOSA

CORNER RECORD

COUNTY OF TOWNSHIP 8 SOUTH, RANGE 18 EAST, M.D.B.&M. CALIFORNIA

NORTHWEST CORNER OF SECTION 1, 8/18.

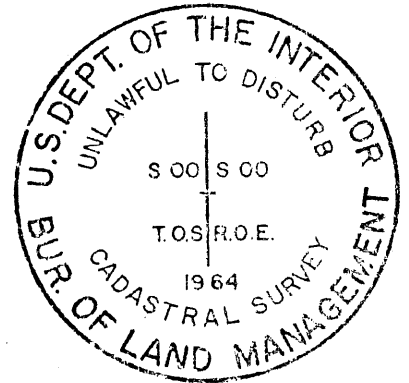
SKETCH: (INCLUDE REFERENCE TIE OR WITNESS POINTS, REMARKS AND TOPO OF AREA)

Found BLM brass cap monument.

S 80°W 70.62 feet 32" Scribed Oak

N 74°35'W 235.62 feet Rotted Oak Stump
